Entertainment Venue Enhances Energy Savings With Thermally Broken Roof Hatches

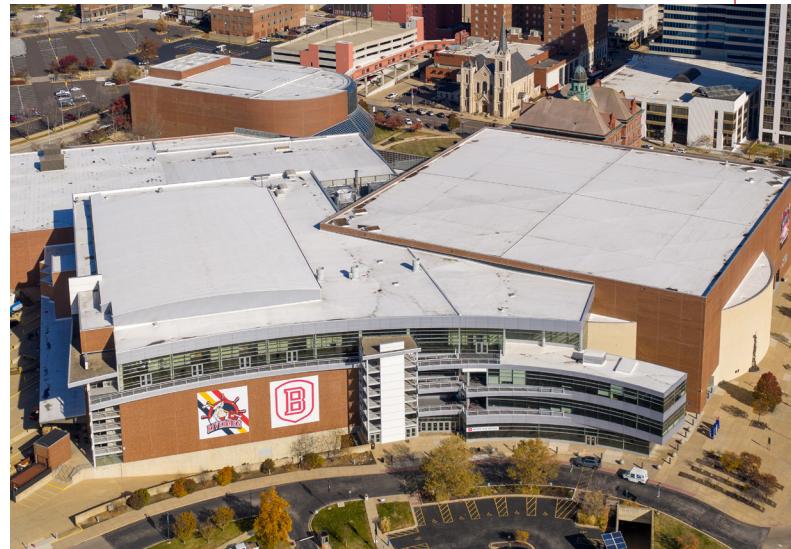
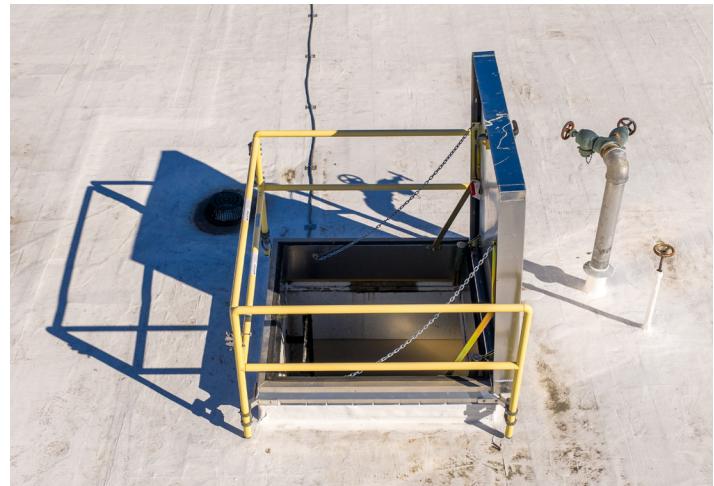
The restoration included two thermally broken roof hatches from BILCO. The 4-feet x 4-feet hatches allow access to the roof above the theater for workers to maintain vents and drains. The hatches feature R-20+ insulation and a frame and cover design that minimizes heat transfer between interior and exterior metal surfaces. The hatches resist harmful condensation and provide superior energy efficiency.

"The insulation of the hatches was an important consideration for this project," Osterman said. "One of the goals of the entire project was to enhance the insulation factor of the building."
